EXTENDING THE OPERATING LIFE OF CRITICAL HIGH VOLTAGE MOTORS

Copyright Material IEEE
Paper No. PCIC-(do not insert number)

Abstract – This paper presents an online partial discharge (PD) trending and data interpretation, related to several similar motors in critical non-spared services. Online partial discharge patterns and trending's were studied to demonstrate if aging conditions were relevant to the motor stator winding. Acquired Phase Resolved Partial Discharge (PRPD) plots were co-related with in-depth stator winding visual inspection which was a collaborative resolution between the Owner, the OEM, and Electrical Motor Services team. A detailed refurbishment and validation test plan was established to reduce surface electrical discharge activity and to extend the in-service life of the motor. A systematic approach with regards to field reconditioning solutions and the life cycle cost reduction was followed and will be explained.

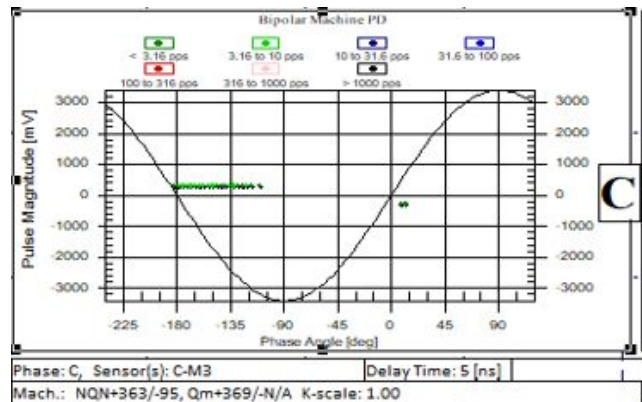
Fig. 1 Positive Predominance Q_m+ 369mV

In preparation for a maintenance outage in 2021, online partial discharge (PD) data was thoroughly analyzed. The collected PD on Phase-C was taken on an insensitive scale (200-3200mV). On that scale, a clear positive predominance, Q_m+ of 369mV as shown in Fig. 1 was detected providing a good indication of surface PD. Comparing to the other phases, data collected on a 50-850 mV scale would be more precise as shown in Fig 2 and 3. The data collected is just at the edge of what is considered the "high" scale or an indication activity is higher than 90% of similar

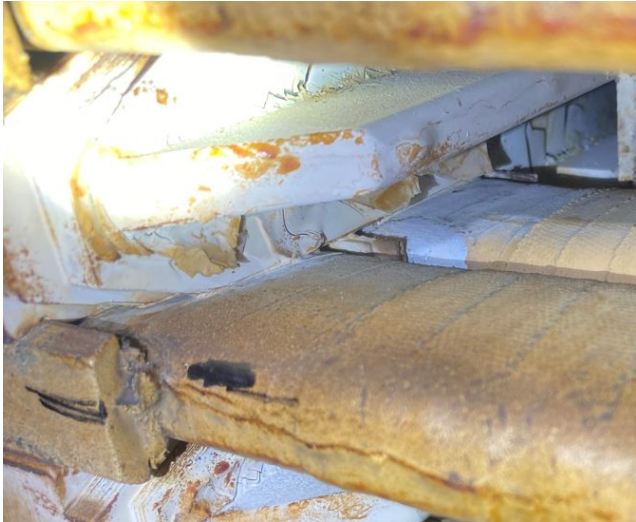
heating and all devices were mechanically secure. There was no evidence of movement around coil blockings and all lashings and bracings were intact. A slight dusting was noted on the coils near the stator slots exits, which can contribute to surface discharge activity. Close inspection of the location where the coil exits the stator slot presented evidence of surface discharges as observed in Fig. 4. Signs of external discharges were found on all line lead coils and adjacent coils at the exit of the stator slot which confirmed the online PD analysis results.

Fig. 4 Surface Partial Discharge Activity

Following discussions with the manufacturer, experienced motor service center, and internal electrical specialists, a decision was made to perform corrective actions in the field to extend the life of the winding and allow sufficient time and planning for future corrective action. To address the accessible areas of the stator winding coils that had been impacted by PD activity, a mitigation strategy and rehabilitation process was employed to restore the stress gradient and corona suppression system. The method of rehabilitation consisted of the following repair actions:

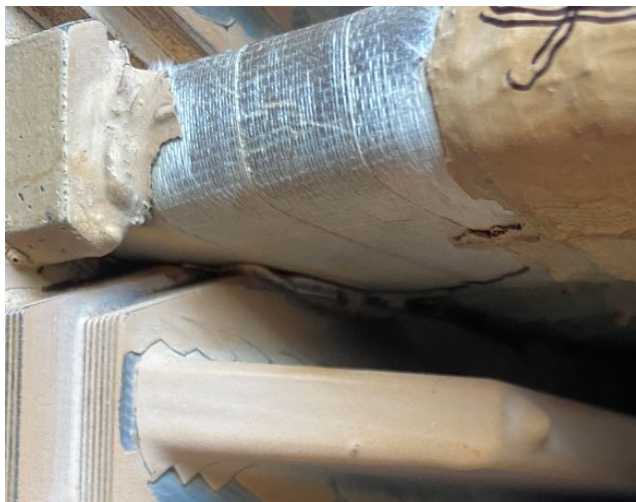
During field inspection of the opposite connection end of the winding (motor drive end), the rotor pole hardware caps and accessible V-blocks were all as expected with no indication of excessive heating and all blocking devices were secure. No evidence of movement around coil blocking was observed with all lashing and bracing intact. A slight dusting was noted on the coils near the stator slots but was irrelevant. Close inspection of the location where the coil exits the stator slot presented evidence of surface discharge as shown in Fig. 5.

Fig. 5 Degradation to Conducting Armor at Slot Exit

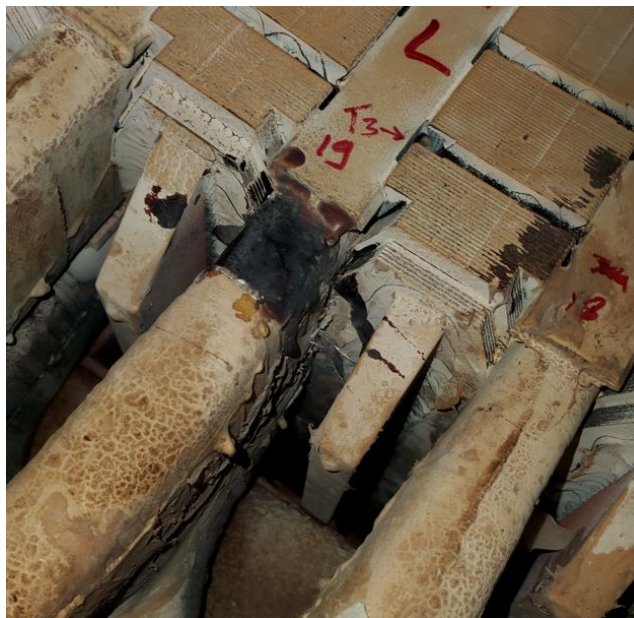
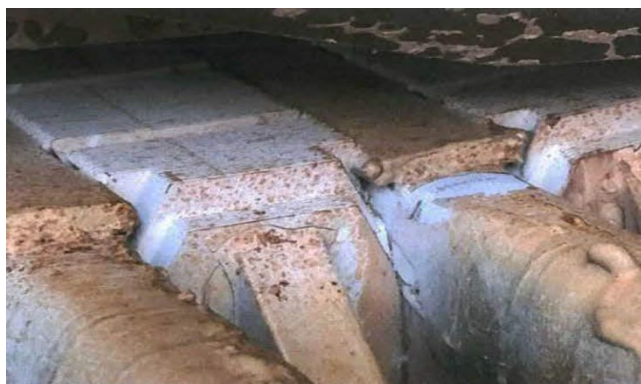
A 30,000 HP, 4-Pole, synchronous, 13.2 kV, motor was installed in 2008 at a Gulf Coast refinery. Table II depicts the motor name plate information. The process condition during its service life was fluctuating which caused several operational cycling and extended acceleration times during certain starting conditions. In 2014, the motor was shut down for offline testing and inspection, with no notable findings. Planning for a 2017 outage, the motor's operational conditions were evaluated, and the motor had slightly elevated vibration trends and an increasing upward PD trend, but the amplitudes of PD were not high enough to flag a concern. A plan was created for the next maintenance window in 2017 to perform a visual inspection and perform offline electrical testing. During the visual inspection, excessive heating was discovered on the rotor poles, and some degradation of the insulation system at the slot exit areas were noticed. Motor winding conditions are reflected in Fig. 17.

Fig. 17 Stator Winding at Slot Exit Locations

At this time the stator insulation system degradation was not fully understood, and the areas of concern were top coated with an epoxy resin.

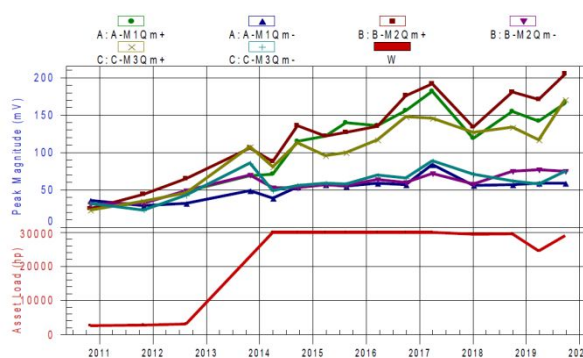
Fig. 18 Online PD Trending

Over the next couple of years, the machine experienced several starts and stops, while monitoring the operational conditions of the motor through online mechanical analysis and PD testing. During the analysis an increasing mechanical vibration was noted. The online PD levels magnitudes were closely evaluated and found to be low in magnitude with an increasing trend over time as shown in Fig. 18, PD trending and Fig 19 PDPR Plots for each phase. A plan was developed for the next maintenance opportunity to remove the motor from service and replace it with a spare motor due to the increased heating on the rotor and increasing vibration trends, the PD trend was not a concern at this time.

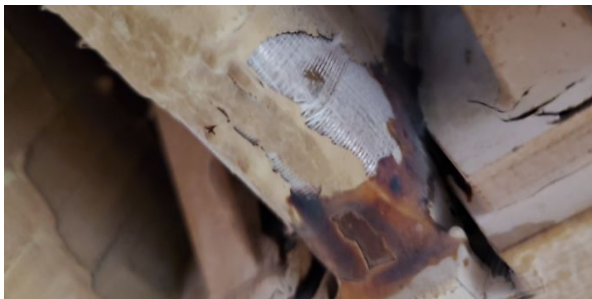
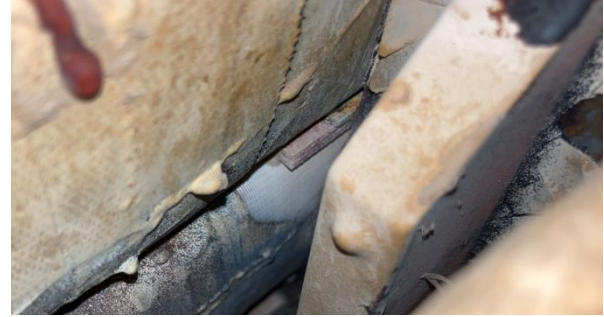
In 2020, the motor was removed from service during a maintenance window and sent to a repair facility with the major scope of work being focused on the rotor rebuild and a stator recondition. The motor stator passed all initial incoming electrical test and was disassembled, and the rotor removed. The stator was cleaned and successfully passed all electrical diagnostic test. A detailed visual inspection was performed and showed major concerns with multiple areas of insulation degradation at the slot exit and the stress gradient to suppression tape joint, Fig. 20 Stator Slot Exit. The locations of the damaged areas were on the connection end of the coils for the first couple of turns.

Fig. 20 Loss of Conducting Armor at Slot Exit Locations

As mentioned previously, the machine has seen excessive starts and stops with an increasing mechanical vibration while in-service. The combination of mechanical and thermal stresses and the thermal growth of the stator coils in the axial direction could have resulted in cracks to both end windings and in the corona suppression system especially, at the stator slot exit locations. Presence of micro-cracks in the line lead coils and a slow degradation of conducting armor while the machine is in-service can be expected due to presence of higher electrical stress. With the online PD trends and the visual confirmation of armor deterioration at the slot exits an upward trend would be expected over the next 10-20 years of service.

The decision was made to perform a complete rewind of the stator based on the criticality of the services, the condition of the insulation system and the rotating element was being rebuilt. Since the decision was made to rewind the stator, we used this opportunity to perform additional testing to better understand the insulation systems condition by allowing us to test to failure. Working with the OEM we developed a comprehensive destructive test plan. The test plan included elevated AC high pot voltages per IEEE Std 4. If during the test a flashover would occur or the test set would trip, the stator would be discharged, and a visual inspection performed to investigate a damaged area. If the test was successful, the next voltage level test would be performed. The test plan was as follows:

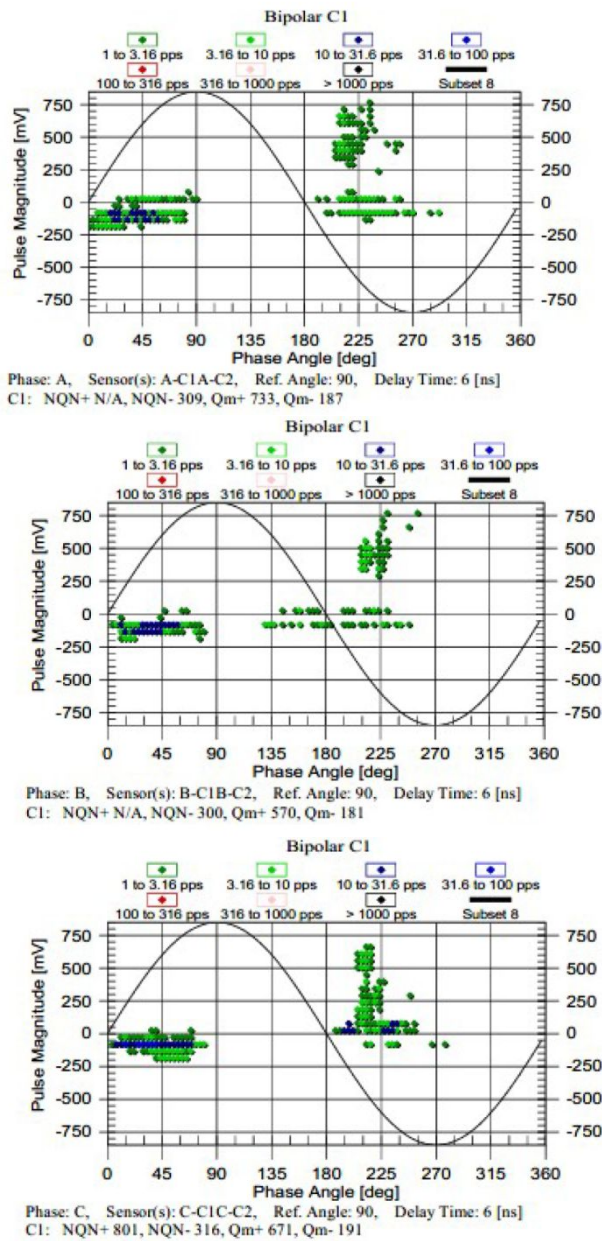
The diagnostic test results and visual inspection report was reviewed to make decision on the repair scope. The windings successfully passed the electrical testing; however, the offline PD test confirmed surface activity, Fig. 21. And in Fig. 22. The degradation of the insulation system was discussed thoroughly with the OEM for the best viable technical solution.

Fig. 21 Offline Partial Discharge Test at 9.6 kV

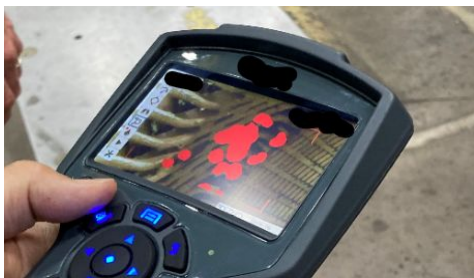
Fig. 22 Observation of Visual Corona

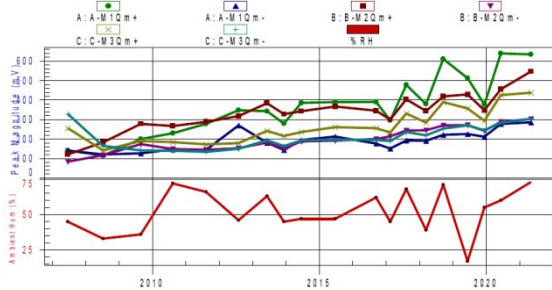
Fig. 23 Online PD Trends

electrically tested. The winding passed the offline testing and inspection with no noteworthy findings. The equipment was placed back in service with the expectation of an additional 10 years of service. During its operation routine monitoring of the machine vibration and on-line partial discharge was performed. While planning for an outage in 2021, the operational parameters were reviewed closely, and a plan was developed to perform offline electrical testing and a visual inspection. The online PD data had been trending upward, reference Figs. 23 & 24. A plan was developed to perform a detailed inspection of the windings, paying close attention to the slot exit and corona suppression to stress gradient joint.

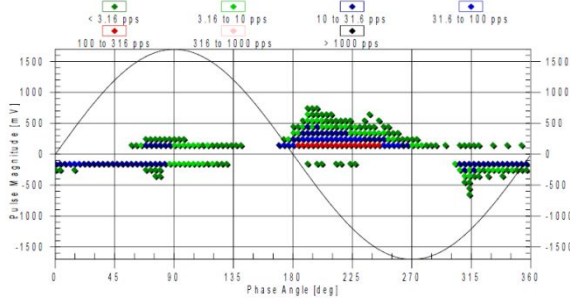
Phase: A, Sensor(s): A-M1, Delay 5ns, Status OK
Machine: NQN+: 1427, NQN-: 517, Qm+: 635, Qm-: 286

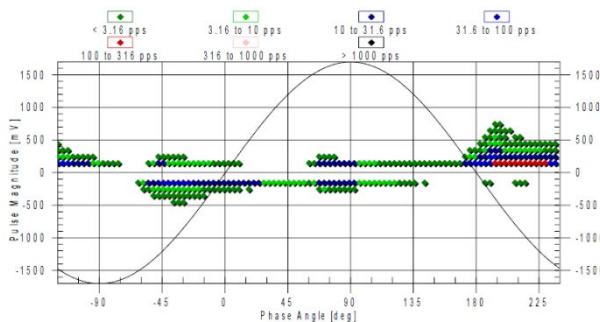
Phase: B, Sensor(s): B-M2, Delay 5ns, Status OK
Machine: NQN+: 1189, NQN-: 629, Qm+: 547, Qm-: 303

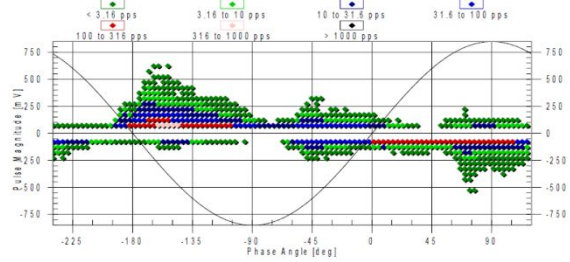
Phase: C, Sensor(s): C-M3, Delay 5ns, Status OK
Machine: NQN+: 1072, NQN-: 705, Qm+: 438, Qm-: 304

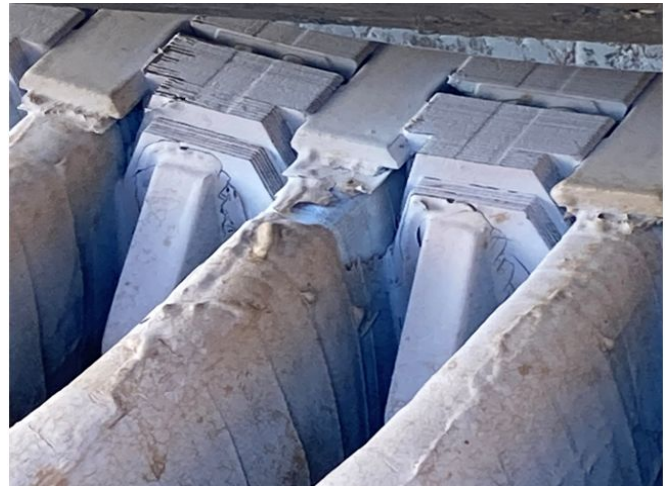
There were three areas of concerns found during the visual inspection (see Fig. 25 example), all of which were on line lead coils in the connection end of the stator winding. The areas were cleaned, and field repairs performed as shown in Fig. 26.

Fig. 25 Line-end Coil Showing Loss of Conducting Armor
