ENSURING ACCURACY AND QUALITY WHEN PERFORMING ARC FLASH STUDIES ON LOW-VOLTAGE POWER DISTRIBUTION EQUIPMENT

Copyright Material IEEE
Paper No. PCIC-

Abstract – This paper highlights major findings, challenges, and approaches in which specific techniques had to be incorporated to perform power system studies and arc flash hazard analysis for multiple gas transportation facilities.

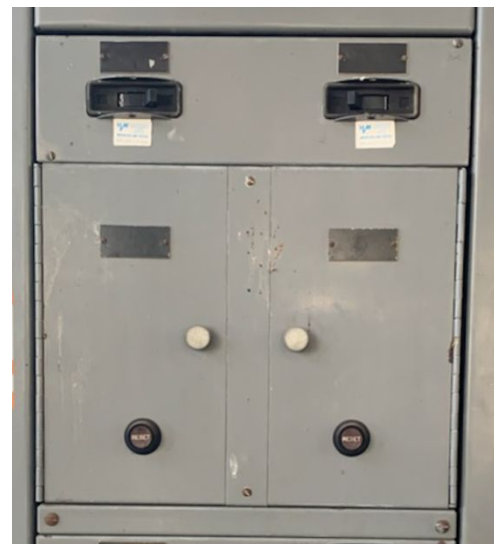
Fig. 1 480VAC MCC Bucket with Unreadable Nameplates

When performing a field site visit to gather information for the arc flash incident energy analysis, there are several items that the individual gathering the field data should consider when performing the visual inspection. Some examples of those visual inspection items are: wiring condition, installation issues, equipment identification/tagging errors, equipment condition and documentation, and missing information such as electrical utility data or equipment nameplates. See Fig. 1 for an example of an unreadable nameplate installed on an MCC.

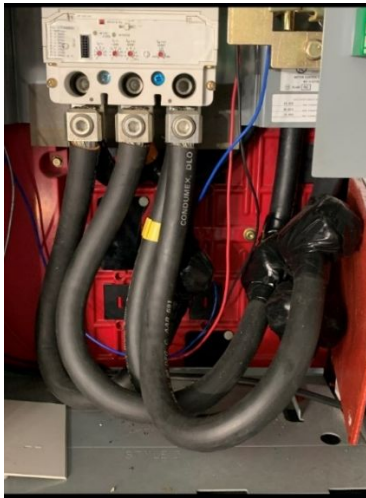
Fig. 2 Cable Spliced in Breaker Enclosure

When collecting the field data, the individual should highlight any issues or concerns that arise such as discolored or damaged wiring, internal or external corrosion including enclosures, any equipment that is damaged or discolored, evidence of vermin or animals, wiring discrepancies, installation issues, or anything that does not appear to be in normal operating condition. See Fig. 2 for an example of a cable installation issue.

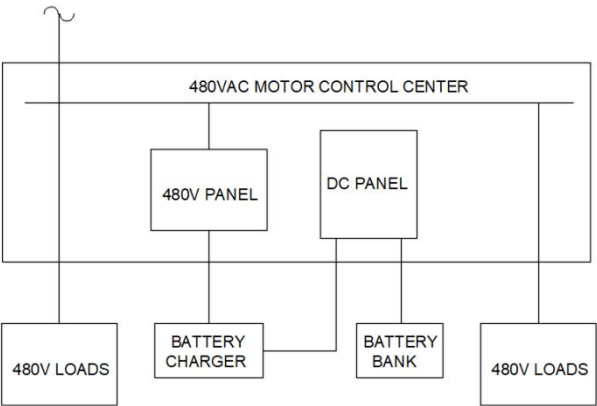
“Site 1” had a 480VAC MCC in which the main circuit breaker was not isolated from the adjacent MCC sections, as would be considered by IEEE 1584-2018 standard [1], with one section containing a 125VDC panelboard. In this case, there is 480VAC bus passing through a 125VDC section. There is also an integral 120/208VAC panelboard fed from a transformer within the MCC section.

Fig. 3 Site 1: 480VAC MCC with Internal DC Panel

For these special instances, consider the worst-case perspective in order to fully protect any workers from potential injuries in the event of arc flash incident. For Sites 1 and 2, since the MCC bus and adjacent sections are not truly isolated from the main circuit breaker, the incident energy value from the line-side of the main circuit breaker shall be assumed to be present at each 480VAC MCC section. There are AC and DC calculations to determine the incident energy values. For the labelling on the 125VDC section that contains 480VAC bus, the 480VAC warning label with the higher incident energy values was installed. For the 125VDC panel, the DC label was installed behind the MCC section door, onto the front of the DC panel door. For this label, the higher incident energy value was used.

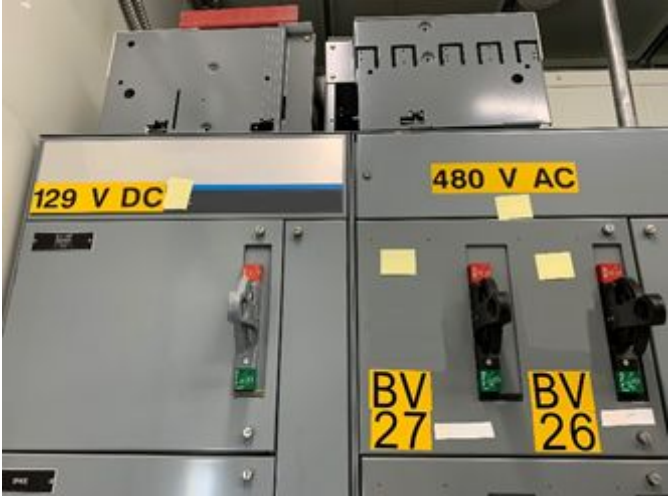
“Site 2” had a 480VAC MCC with one section rated 129VDC that is not completely isolated from the 480VAC bus, as would be considered by the IEEE 1584-2018 standard [1]. Further, the bottom floors of the MCC sections are open to allow the passage of cables through the subfloor.

Fig. 4 Site 2: MCC with 480VAC and 129VDC Sections

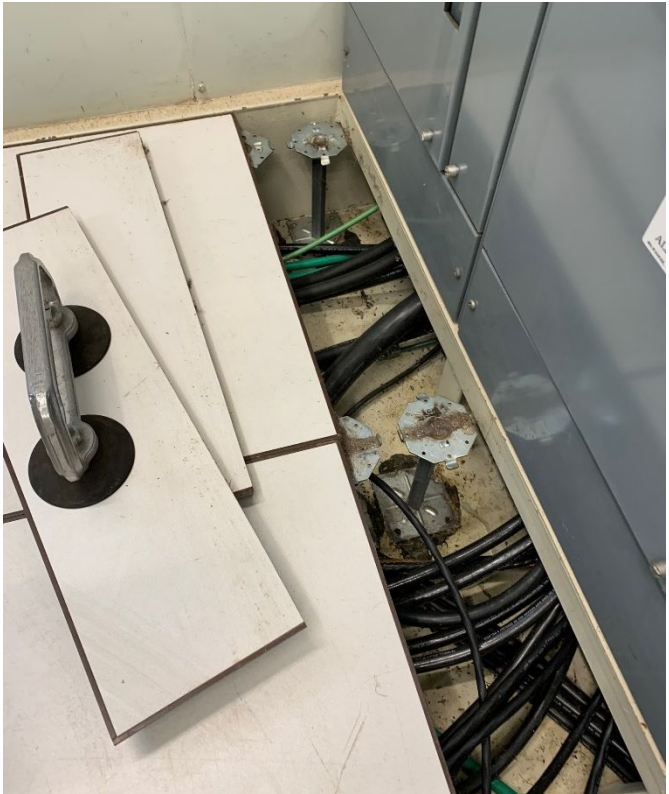
Fig. 5 Site 2: 480VAC and 129VDC MCC Sub-Floor

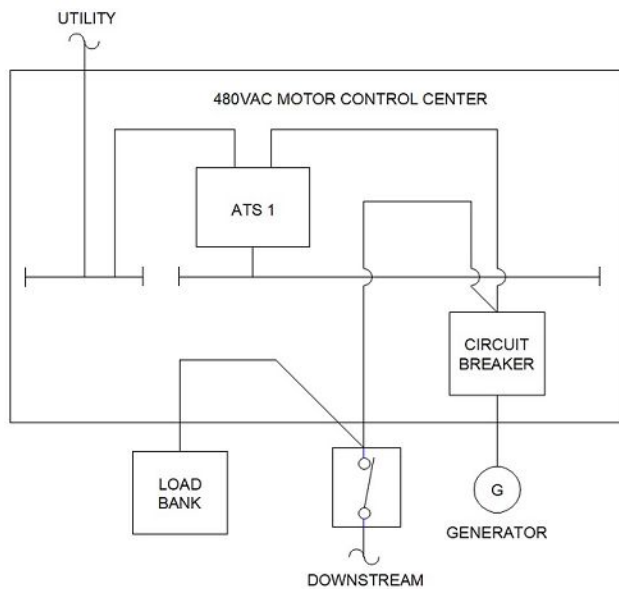
“Site 3” had the generator main circuit breaker located within the MCC, along with the Automatic Transfer Switch (ATS). This is a familiar case of load side vs. line side labels. However, the generator cables are also routed to a load bank located outside via a Disconnect Switch, which also feeds downstream equipment. Therefore, the normal mode of operation is to exercise the generator from the load bank. Hence, the 480VAC MCC would have both utility as well as generator power available when performing a generator test while connected to the load bank. Simultaneously, the utility source is providing power to the site’s load. Since the ATS nor the generator circuit

breaker are isolated from the MCC bus, the conservative approach is to choose the normal or the generator power source (line-side) that yields the higher incident energy results. An alternative method that may be considered is to utilize the closed transition state for the ATS to take into account the overlap in which both sources are energized. Note that generally an ATS is fed from the utility and generator only momentarily. But any instance where the ATS is fed from a generator with a load bank, both sources would be energized for prolonged periods of time.

Fig. 6 Site 3: 480VAC MCC with Internal ATS & Generator CB

For Site 3, the worst-case incident energy needs to be determined in normal mode and emergency (generator mode) to include in the calculations or alternatively select a closed-transition state for the ATS.

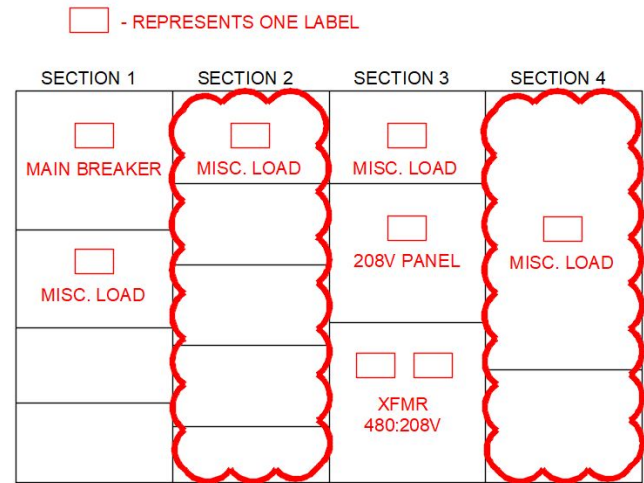
The project scope as agreed to with the Owner is that there will be one arc flash label applied per MCC section unless there are two different voltage sources of equipment or if the calculations result in different incident energy values within the same section. Fig. 8 depicts the label placement for a 480VAC MCC that has a main breaker that is isolated from the downstream bus. The Main Breaker in Section 1 would have a label in which the incident energy is calculated at the line side of the main breaker. The MCC buckets noted as “Misc. Load” would have labels in which the incident energy is calculated at the load side of the main breaker. Note that the clouds at MCC Sections 2 and 4 indicate that there is one label per MCC section. For Section 3, since there is a 480V:208VAC transformer and a 208VAC panelboard, each of these MCC buckets would have a label applied. The 480:208VAC transformer has a primary and secondary label applied since the higher incident energy is typically seen at the secondary of the transformer. In the event of a MCC breaker that is not isolated, each MCC section would have the same incident energy value as that of the main breaker.

Fig. 8 Label Locations for a MCC with Isolated Main Breaker

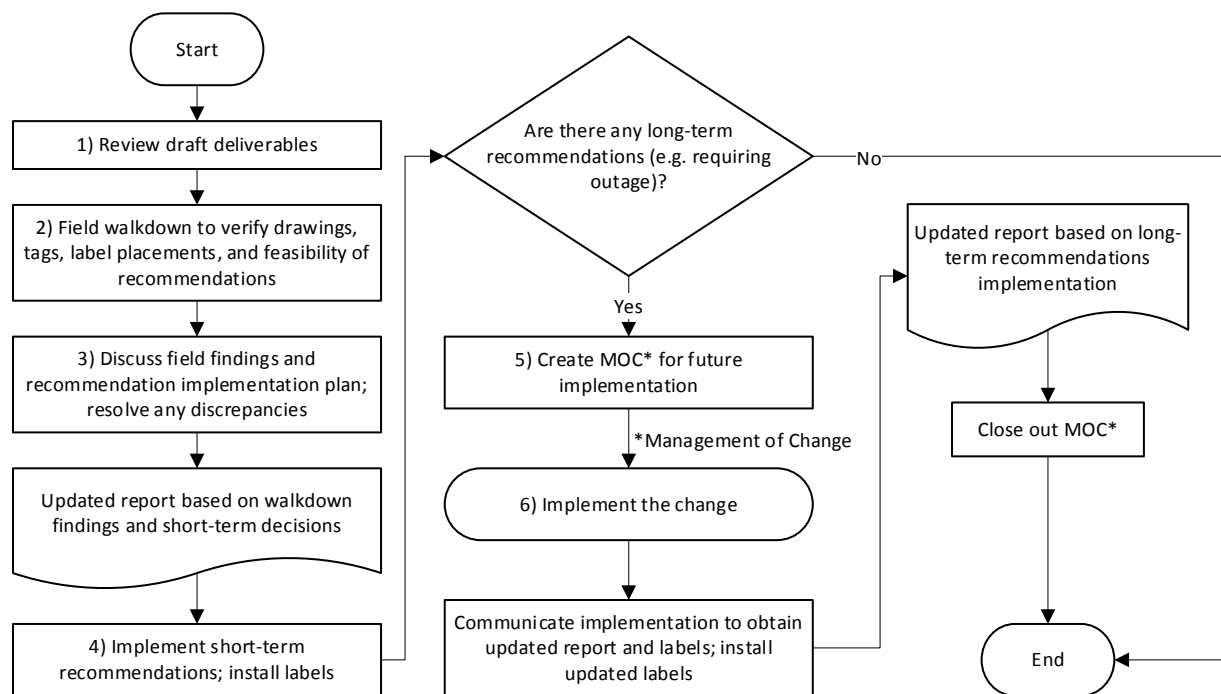
APPENDIX A QA/QC PROCESS FLOWCHART

The field QA/QC check typically consists of the following steps:

Knowledge of the studies, models, labels, assumptions, etc. will allow the field staff to better manage and steward the quality and accuracy of the studies over time for each site. A flowchart and explanation of the QA/QC process is shown in Appendix A.

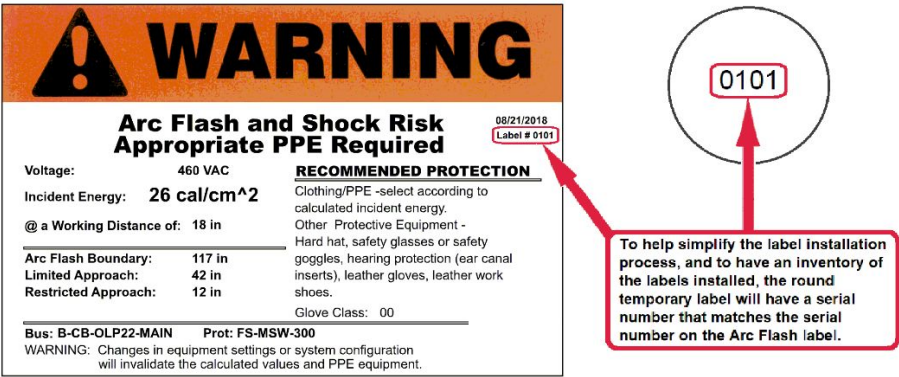
Fig. 10 Placeholder Label and Arc Flash Label

Placeholder labels are installed as a temporary basis during the initial data gathering phase of each project. These labels have a printed serial number on them that will match the serial numbers on the CAD drawings as well as the final printed arc flash labels. They can be used as an inventory number for reference throughout the life of the equipment. These labels
